Fluvial Geomorphology Assessment of Grand Lake Stream, Maine

Maine Inland Fisheries and Wildlife

Field Geology Services
Farmington, ME

May 2006

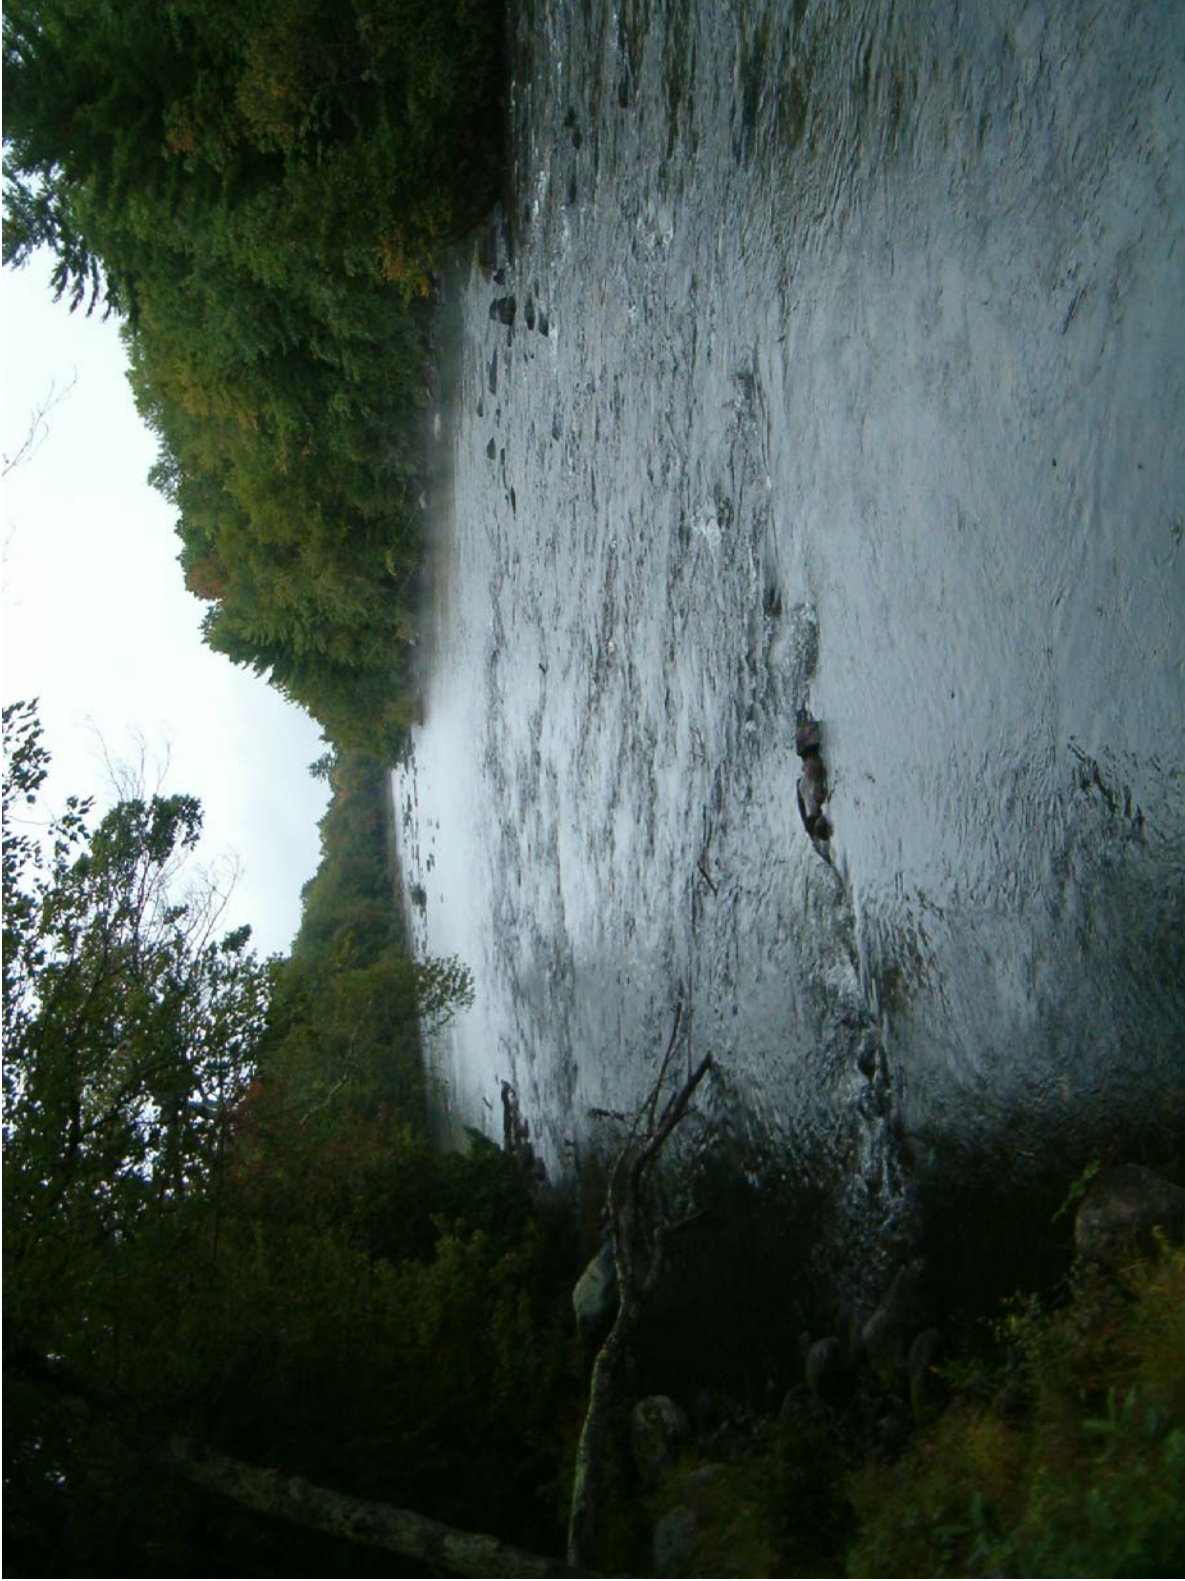
Overwidened Stream Channel

Note: Looking downstream near fish hatchery

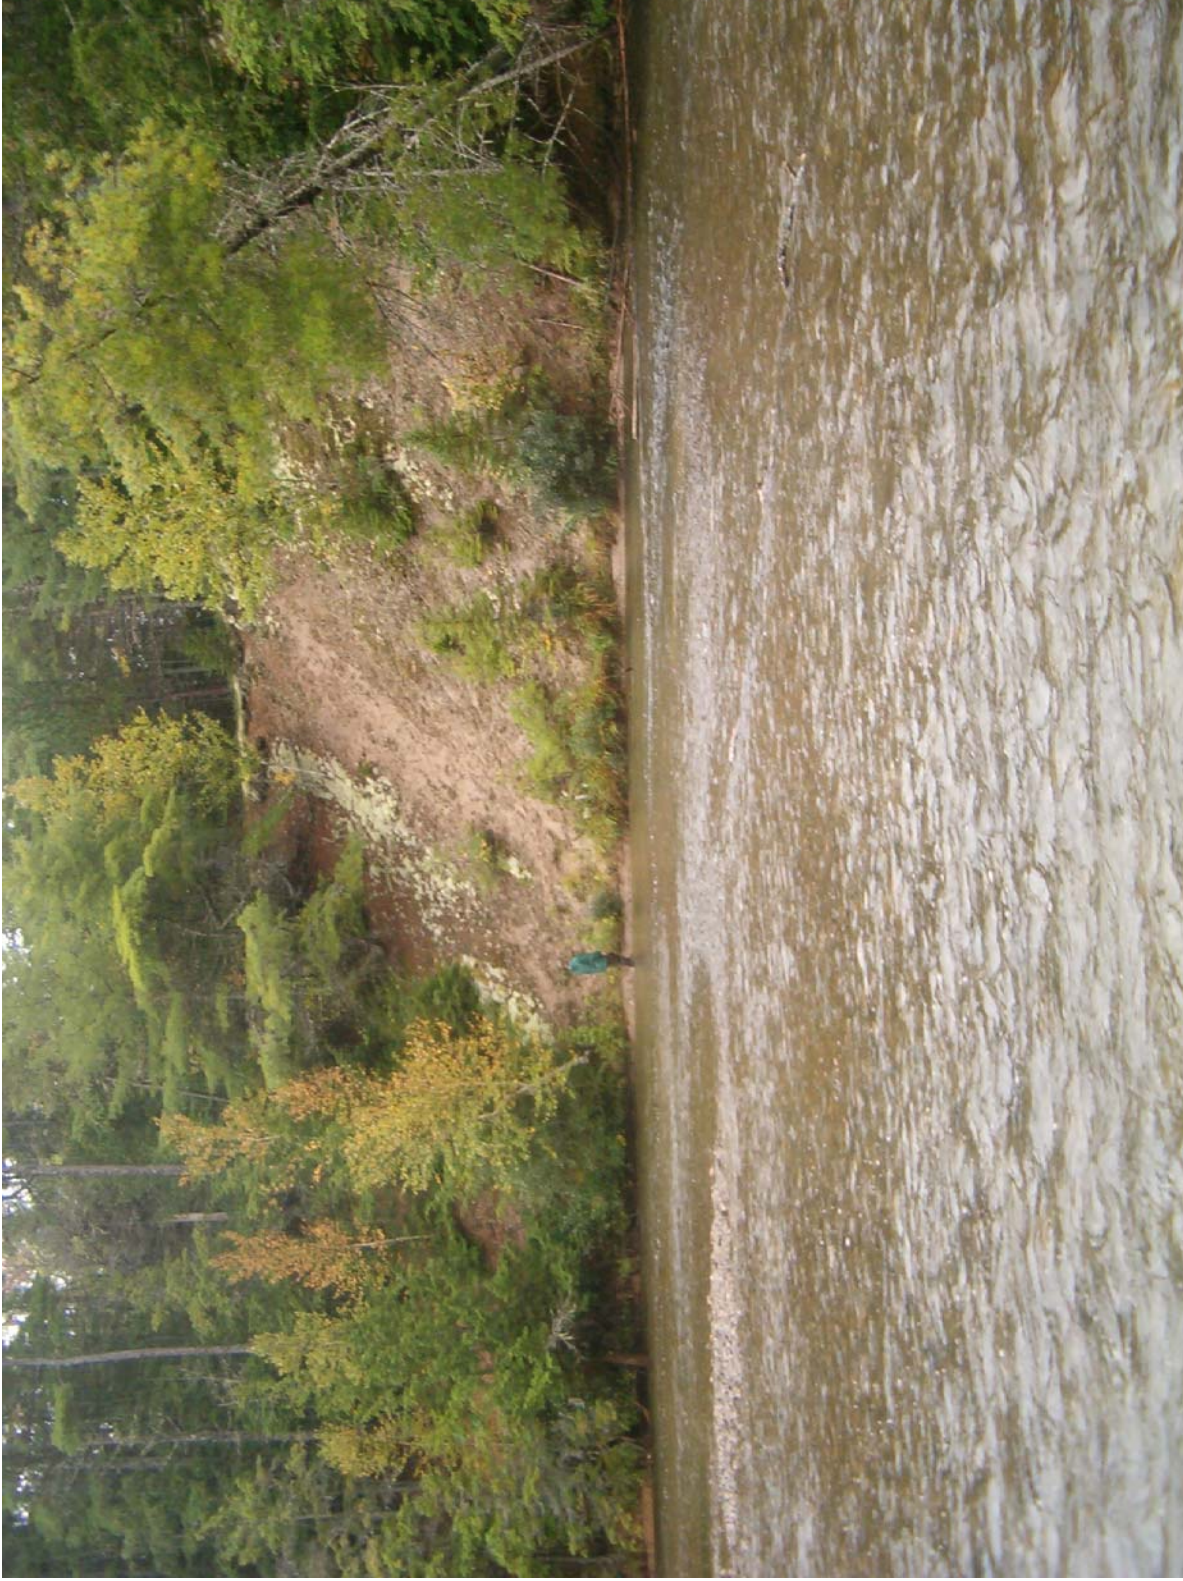
High Eroding Bank

Note: Upstream of Little Falls

Anchoring logs and root wads to the base of the high eroding bank would deflect water away from the high bank while providing cover. The restoration work would mimic natural debris jams that form along rivers and streams with high wood loads. While such jams are not currently abundant on Grand Lake Stream, they may have existed before the intense land clearing that accompanied settlement of the region. As the current forests continue to mature and older trees die off over the next several decades, natural log jams may form again along the banks of Grand Lake Stream. Unlike riprap, flow into the bank would be baffled by log jams, so downstream impacts or intense scour at the base of the bank are less likely. To avoid destabilizing the bank, the logs and root wads should not be inserted into the bank but rather cabled to rock on the bank or buried in the bed of the channel. Installing the logs and root wads might require the use of excavators, which would cause some disturbance in the channel. As a result, doing nothing is the preferred option for Reach 2, because of the potential impacts associated with the other options. However, anchoring logs and root wads to the base of the high eroding bank, as the least disruptive and most natural of the restoration options, should be considered further if rapid recession of the high bank is observed and the sediment generated from such erosion becomes a more serious concern.

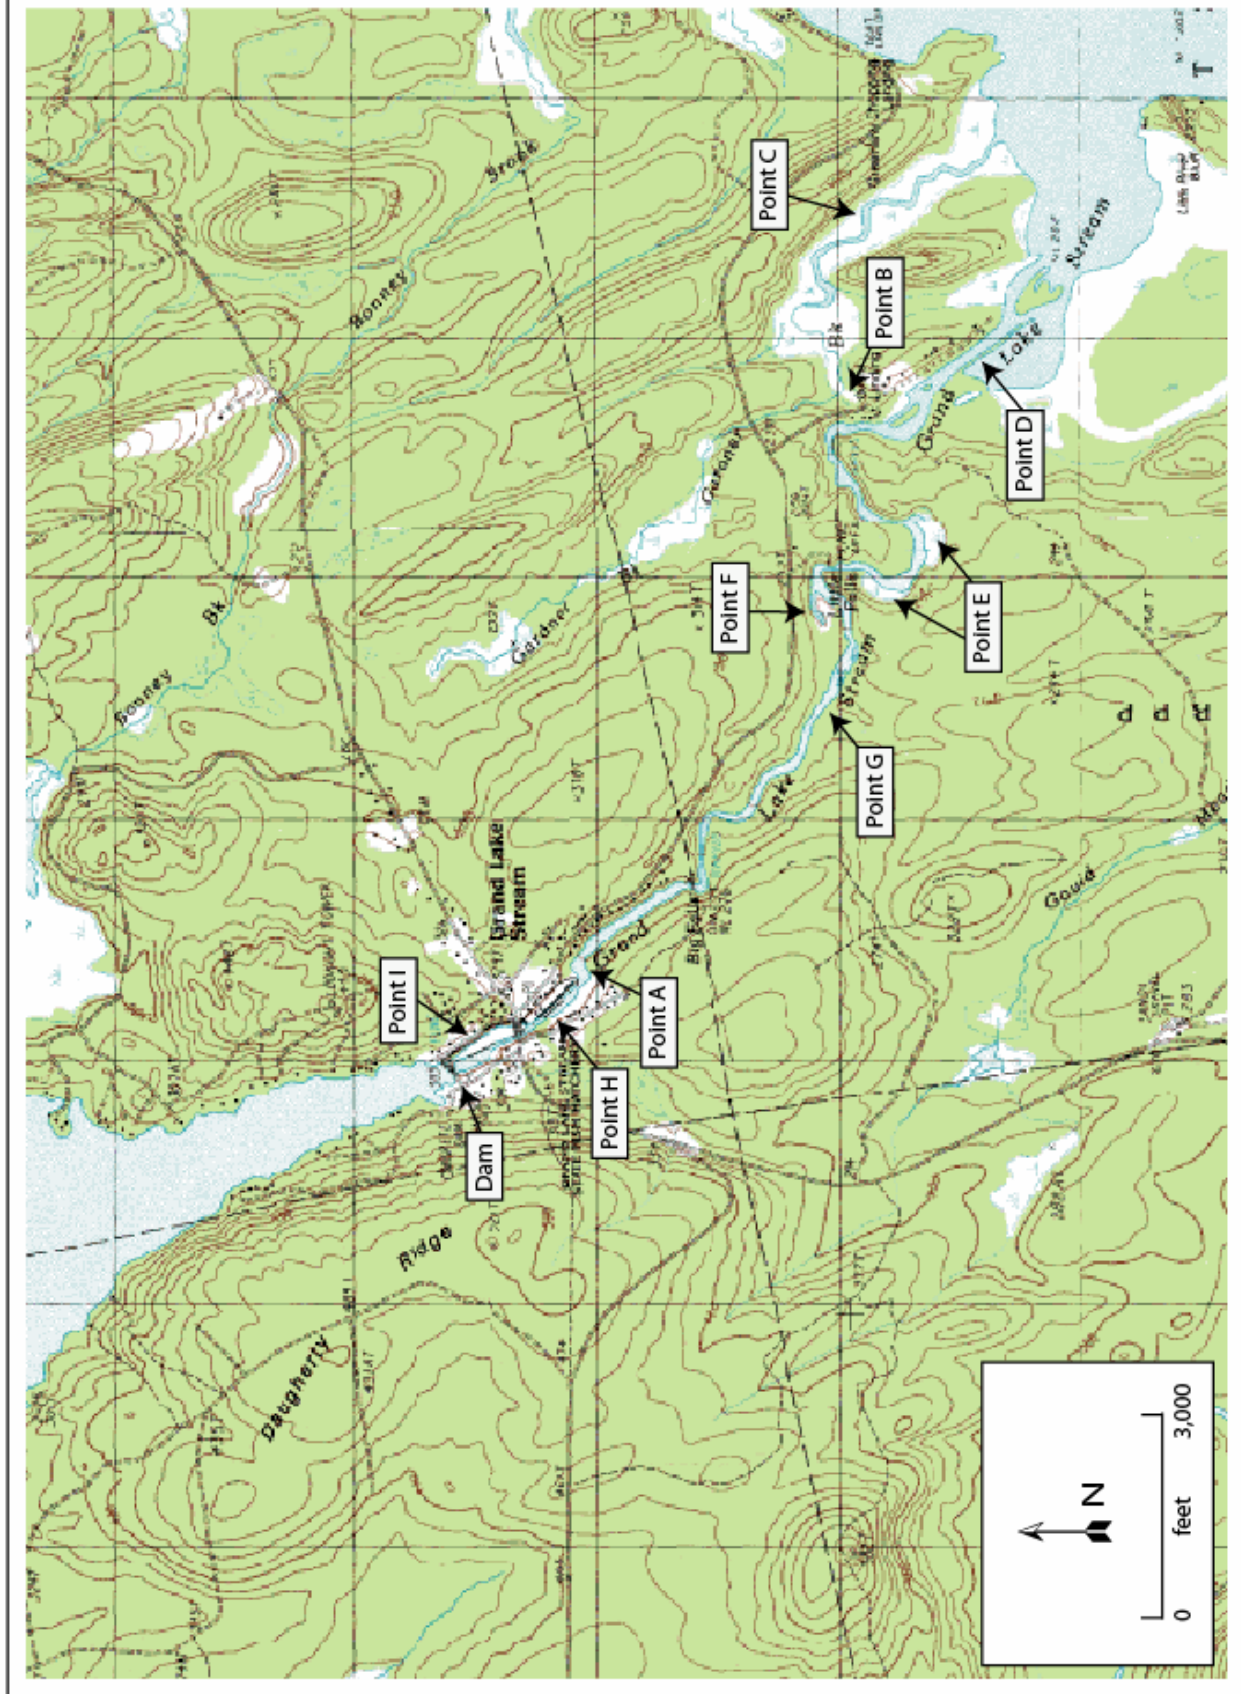
Channel Changes on Grand Lake Stream

and current maps is that Gardner Brook currently flows directly into Big Lake but in 1941 flowed into Grand Lake Stream near Gould Landing (Figure 5 – Point B).

Note: See text for description of lettered points

Dismantling portions of the long constrictor on the right bank of the channel (Figure 5 – Point D) would restore additional flow to the marshy area behind. More regular flow in the marsh would likely enhance the marsh ecology and provide habitat benefits. However, the loss of flow from the channel would promote further deposition and result in an even shallower channel. The preferred option at the site depends on priorities of the landowners and other interested parties. If the priority is maintaining water depths in the channel for boating, then reconstruction of the constrictors with dredging is the best option despite the environmental consequences. Reconstruction also presents an opportunity to preserve historical cultural resources and provide a living reminder of the importance of logging and log drives to early settlers of the region. However, if the creation and restoration of a natural ecosystem is the priority, then partial deconstruction of the constrictor is the best option as this most closely mimics what will naturally occur over time and what would have developed if the constrictors had never been built.

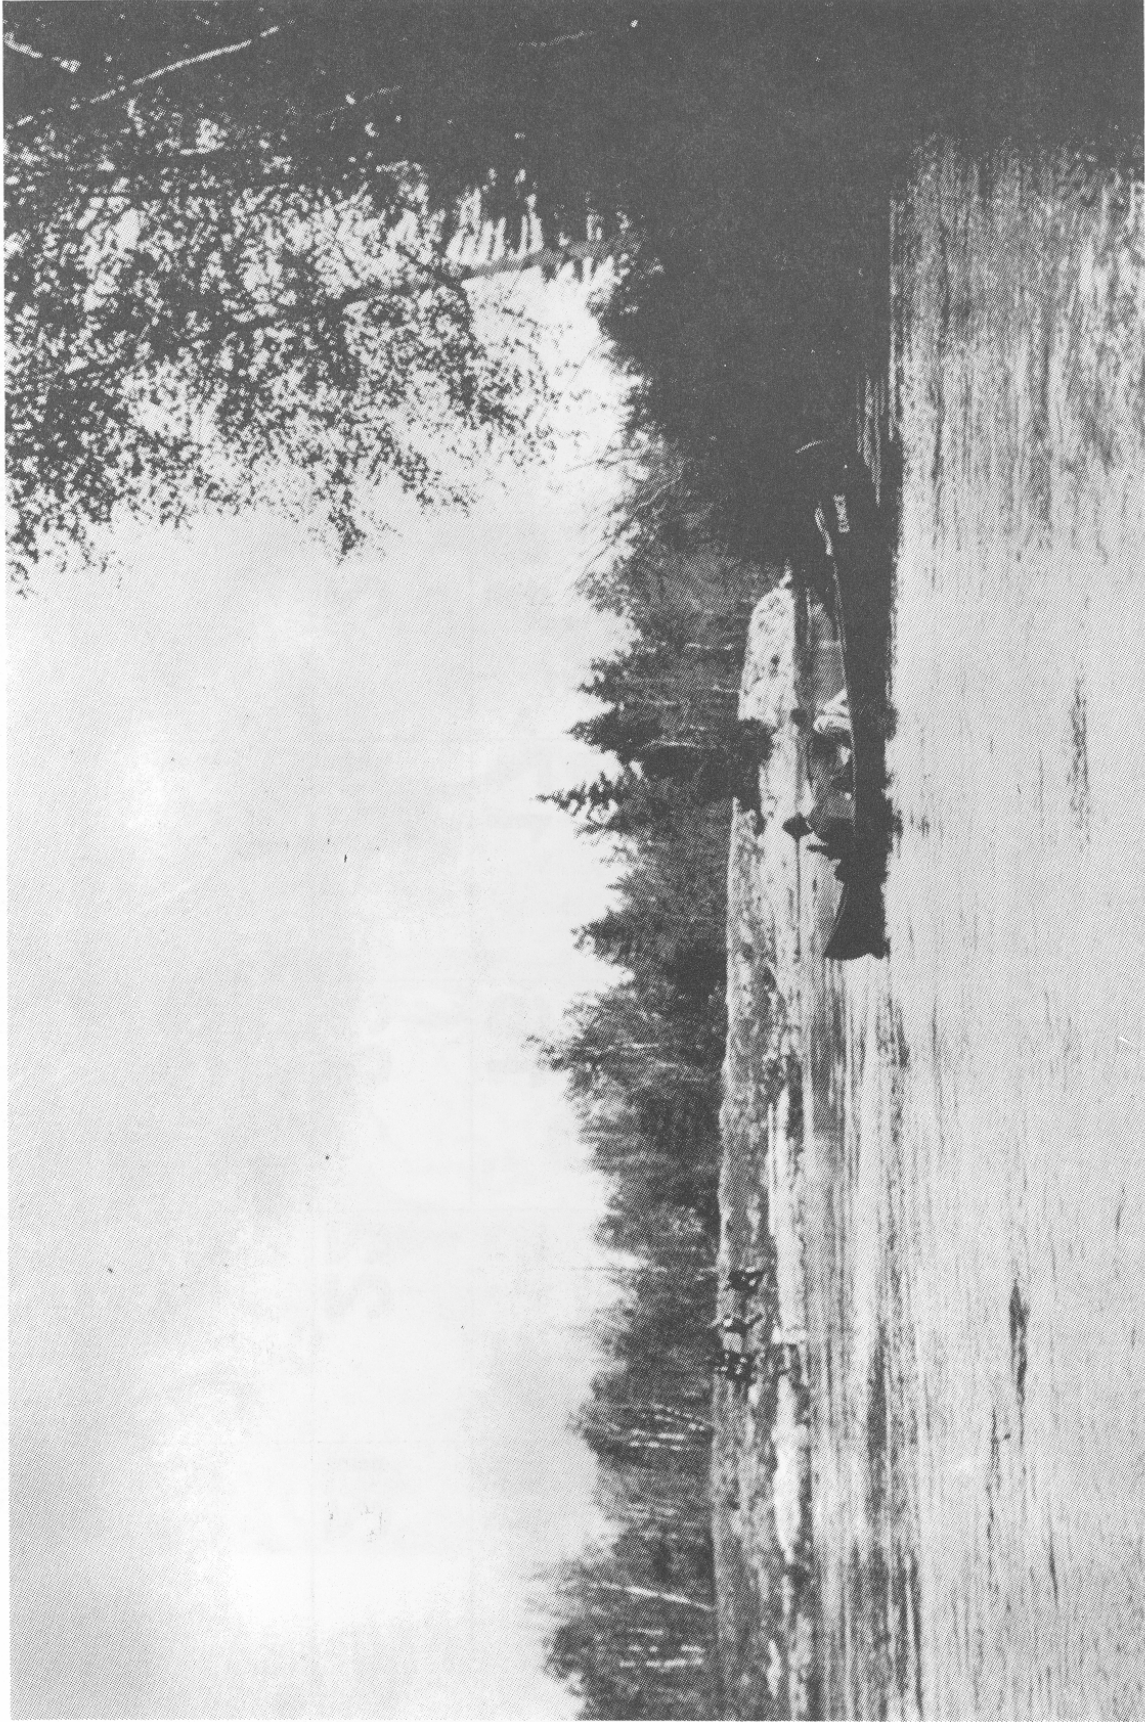
Grand Lake Stream Upstream of Little Falls in 1917

A ground photograph upstream of Little Falls in 1917 shows the channel in its current position (Figure 8), indicating that artificial straightening and abandonment of the meander occurred prior to this time.

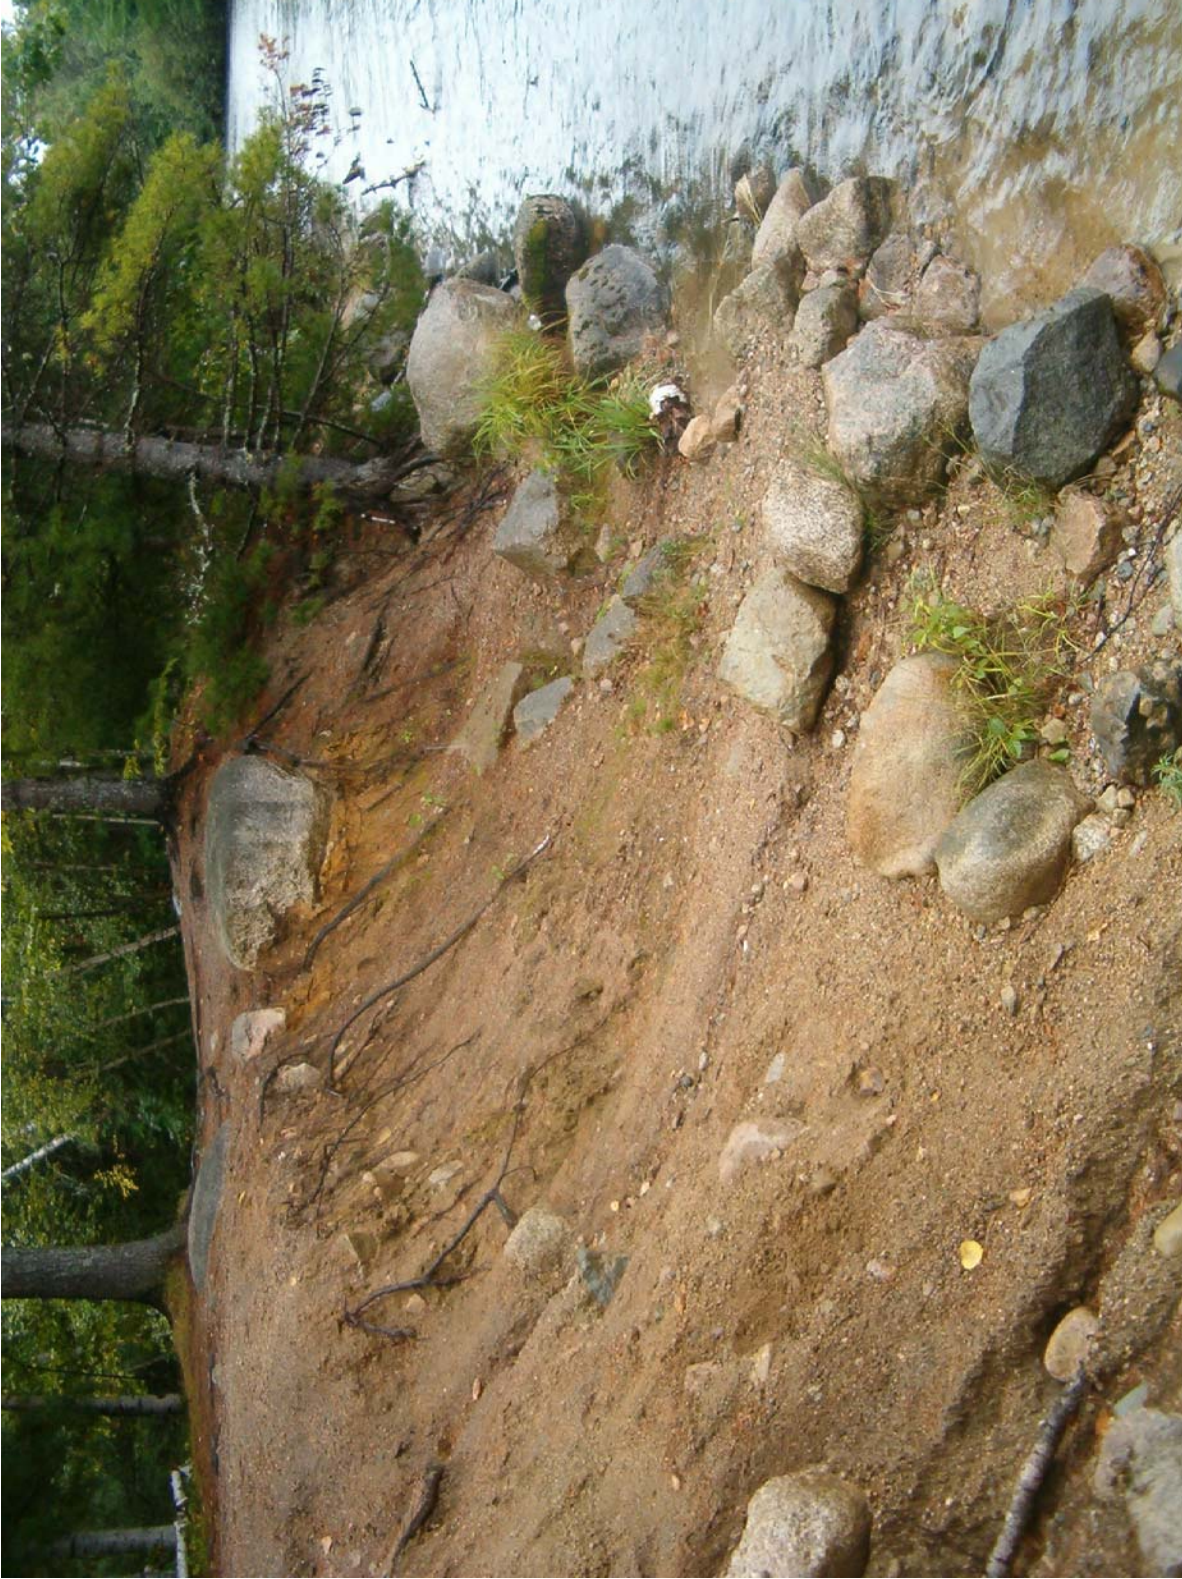
Erosion Downstream of Dam

Very little erosion is observed along Grand Lake Stream (< 3 percent) with some found immediately downstream of the dam (Figure 10 and Appendix 2). Additional erosion is found between Big Falls and Little Falls with a particularly high eroding bank located 950 feet upstream of Little Falls (Figure 4). While some residents further downstream believe this bank is a source of considerable sediment, a resident with a view of the bank indicates that the bank has changed very little in over 20 years. Lichen and tree growth on the sandy bank and the absence of vertical faces is consistent with the lack of significant erosion. However, the absence of mature trees on the bank and recently fallen trees just downstream suggest the bank is unstable and susceptible to erosion. A mid-channel bar situated adjacent to the high eroding bank is diverting a portion of the flow directly into the bank, perhaps leading to the erosion. Whatever excess sediment is eroded from this bank is unlikely to be transported much further than immediately downstream of Little Falls where the valley becomes much wider and extensive deposition is observed.

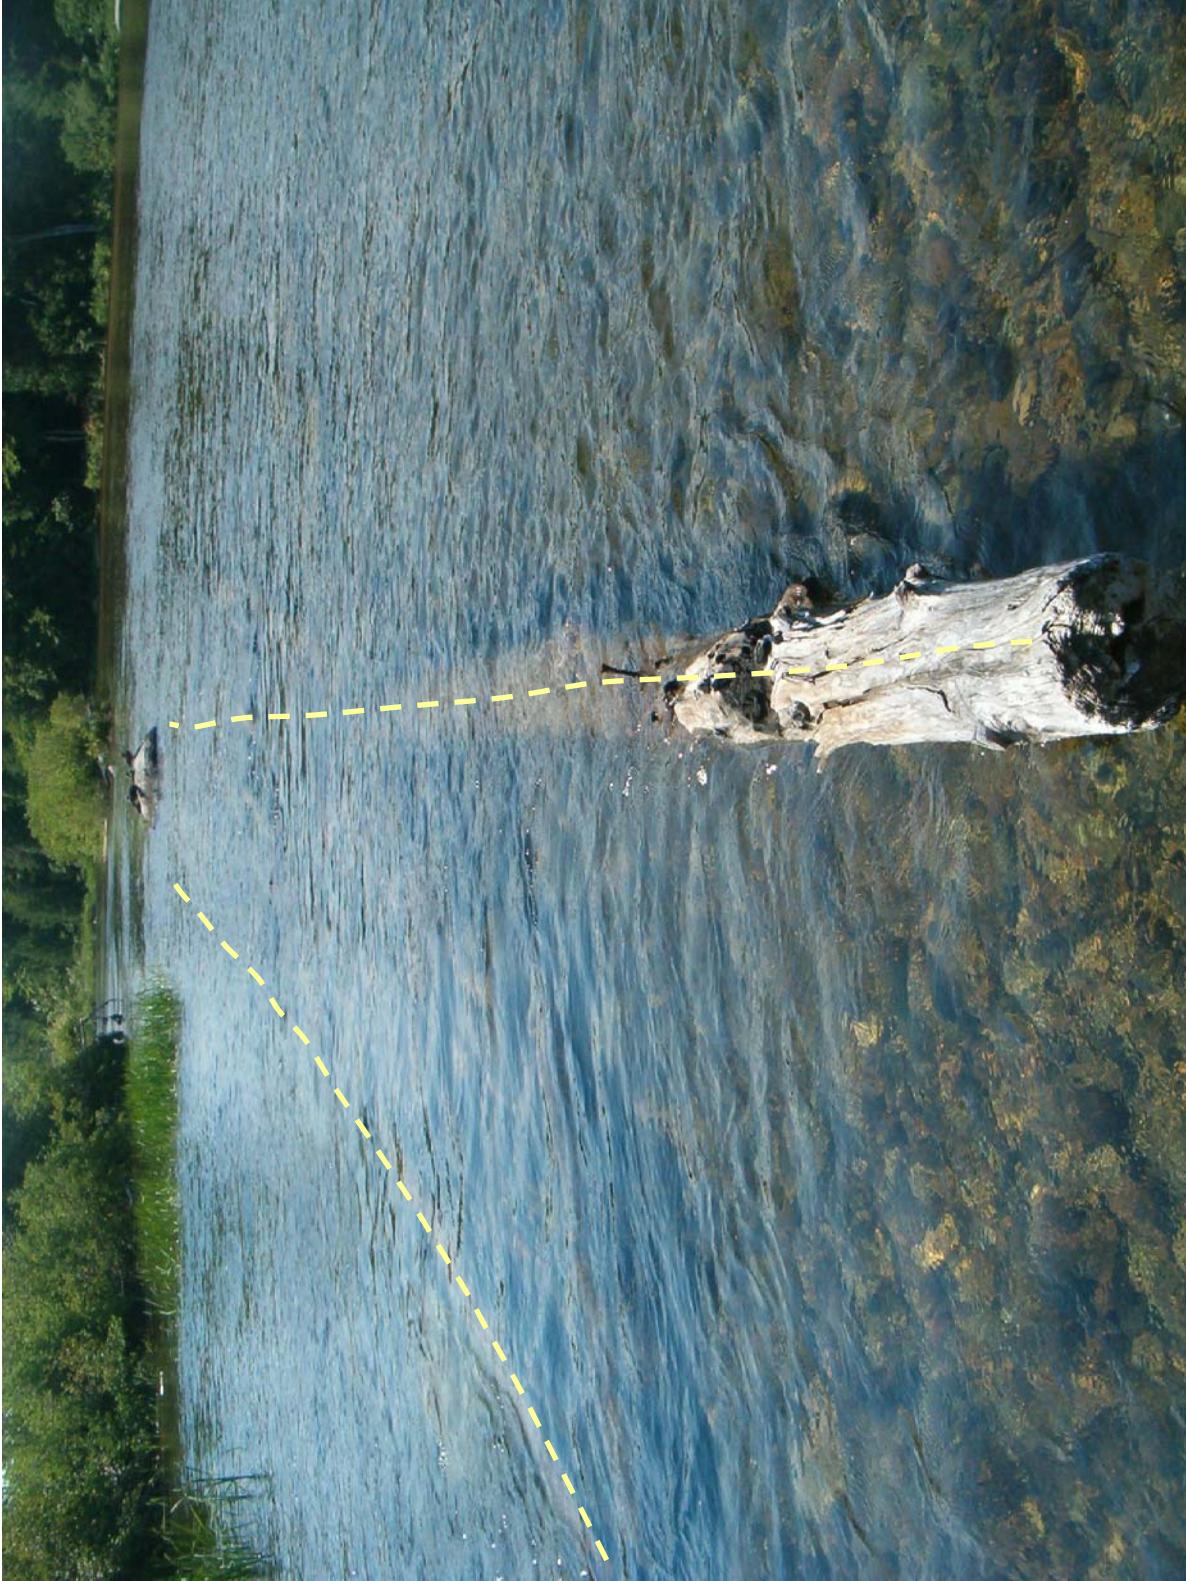
Old Channel Constrictor in Disrepair

Mid-channel bars are found along 7 percent of the length of Grand Lake Stream with most of these concentrated between Big Falls and Little Falls (Table 1 and Appendix 2). These gravel bars have formed downstream of where the channel is confined between high nonalluvial slopes of glacial deposits. The loss of valley confinement leads to deposition as flow spreads out into numerous side channels and flow velocities reduced. Several flow deflectors and constrictors (i.e., weirs or crib walls) have been built along the stream, including just upstream of these mid-channel bars, where natural valley confinement is lost (Appendix 2). The construction of these constrictors was likely associated with log drives in an effort to block flow from entering side channels, maintain flow velocities, and improve the transport of logs downstream. Since the end of log drives, many constrictors have fallen into disrepair, allowing flow to more regularly access side channels (Figure 11).

Several places along the stream were artificially constricted by constrictors built with log cribbing filled with rock (Figure 11). As the constrictors fall into disrepair, flow

to previously blocked side channels has resumed, leading to the loss of stream energy and deposition of sediment entrained in the water. This deposition is causing the formation of mid-channel bars and deltas that are diverting water into unstable banks (Figure 4) and infilling already shallow channels. The loss of channel depth due to flow expansion through old constrictors downstream of Gould Landing is particularly troublesome for landowners trying to access the channel with boats. Restoration of the constrictors may sustain channel depths but runs counter to natural stream processes in low gradient unconfined stream reaches. Consequently, periodic maintenance would be required to maintain sufficient channel depth. Greater improvements to channel stability and aquatic habitat can be expected where restoration mimics natural stream processes and evolution. As such, the addition of boulder clusters between the fish hatchery and Big Falls has the greatest chance of successfully restoring and sustaining natural stream channel conditions and pool habitat.

Note: Dashed lines represent outer margins of log cribbing that comprised the constrictor

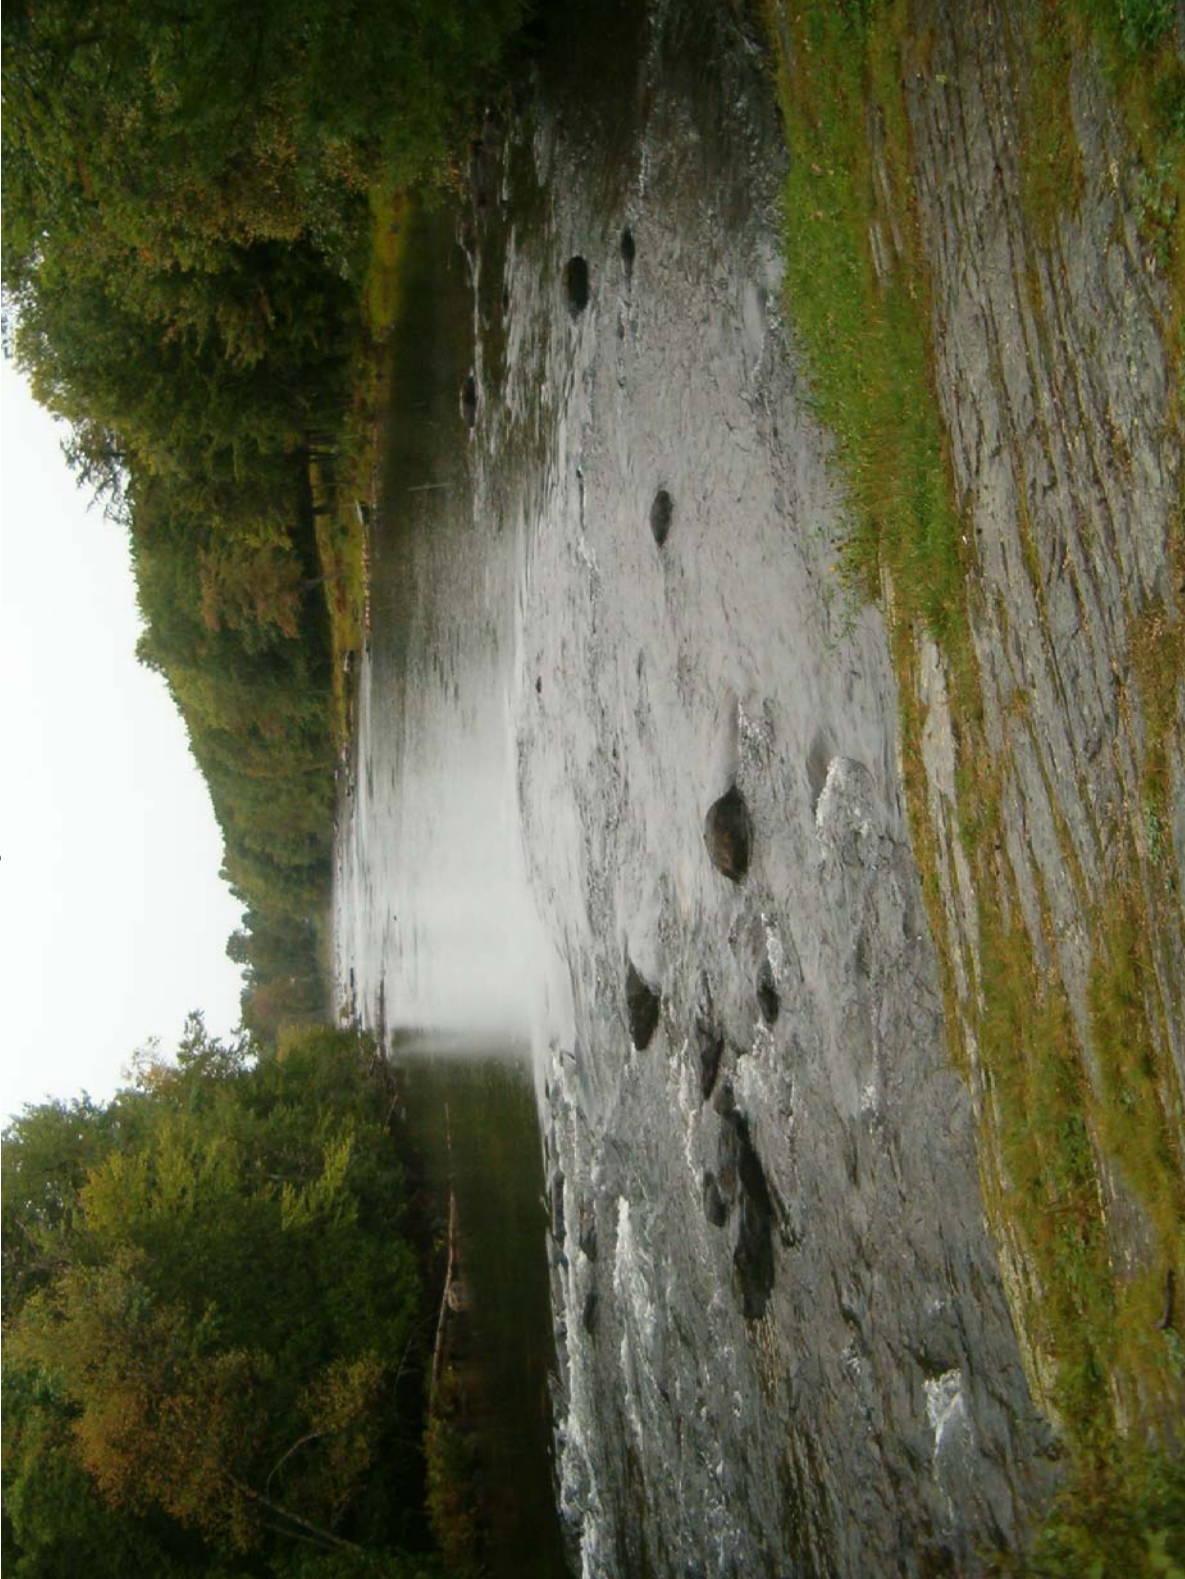
Study Reach 1

Reach 1 extends from the downstream end of the fish hatchery to Big Falls (Figures 2 and 12). The reach is straight and may have been artificially straightened, although this remains uncertain given that the narrow floodplain would limit natural sinuosity. The high width:depth ratio (> 30.0) of the channel is consistent with a channel response to artificial straightening, but may also reflect the inability of the channel to erode through the coarse channel substrate inherited from the surrounding glacial deposits (see Section 5.0 below). Several boulders are found along the banks with only a few located in the center of the channel, suggesting boulders were removed to ease the floating of logs downstream. Where boulders are present in the stream, deep pools have formed around them, sometimes both upstream and downstream (Figure 13). Pools are otherwise widely spaced and shallow, although, given the wide channel, pools are closely spaced at every 1.3 bankfull widths compared to an expected spacing of 5 bankfull widths (Table 2; Rosgen, 1996).

Note: Looking upstream from Big Falls

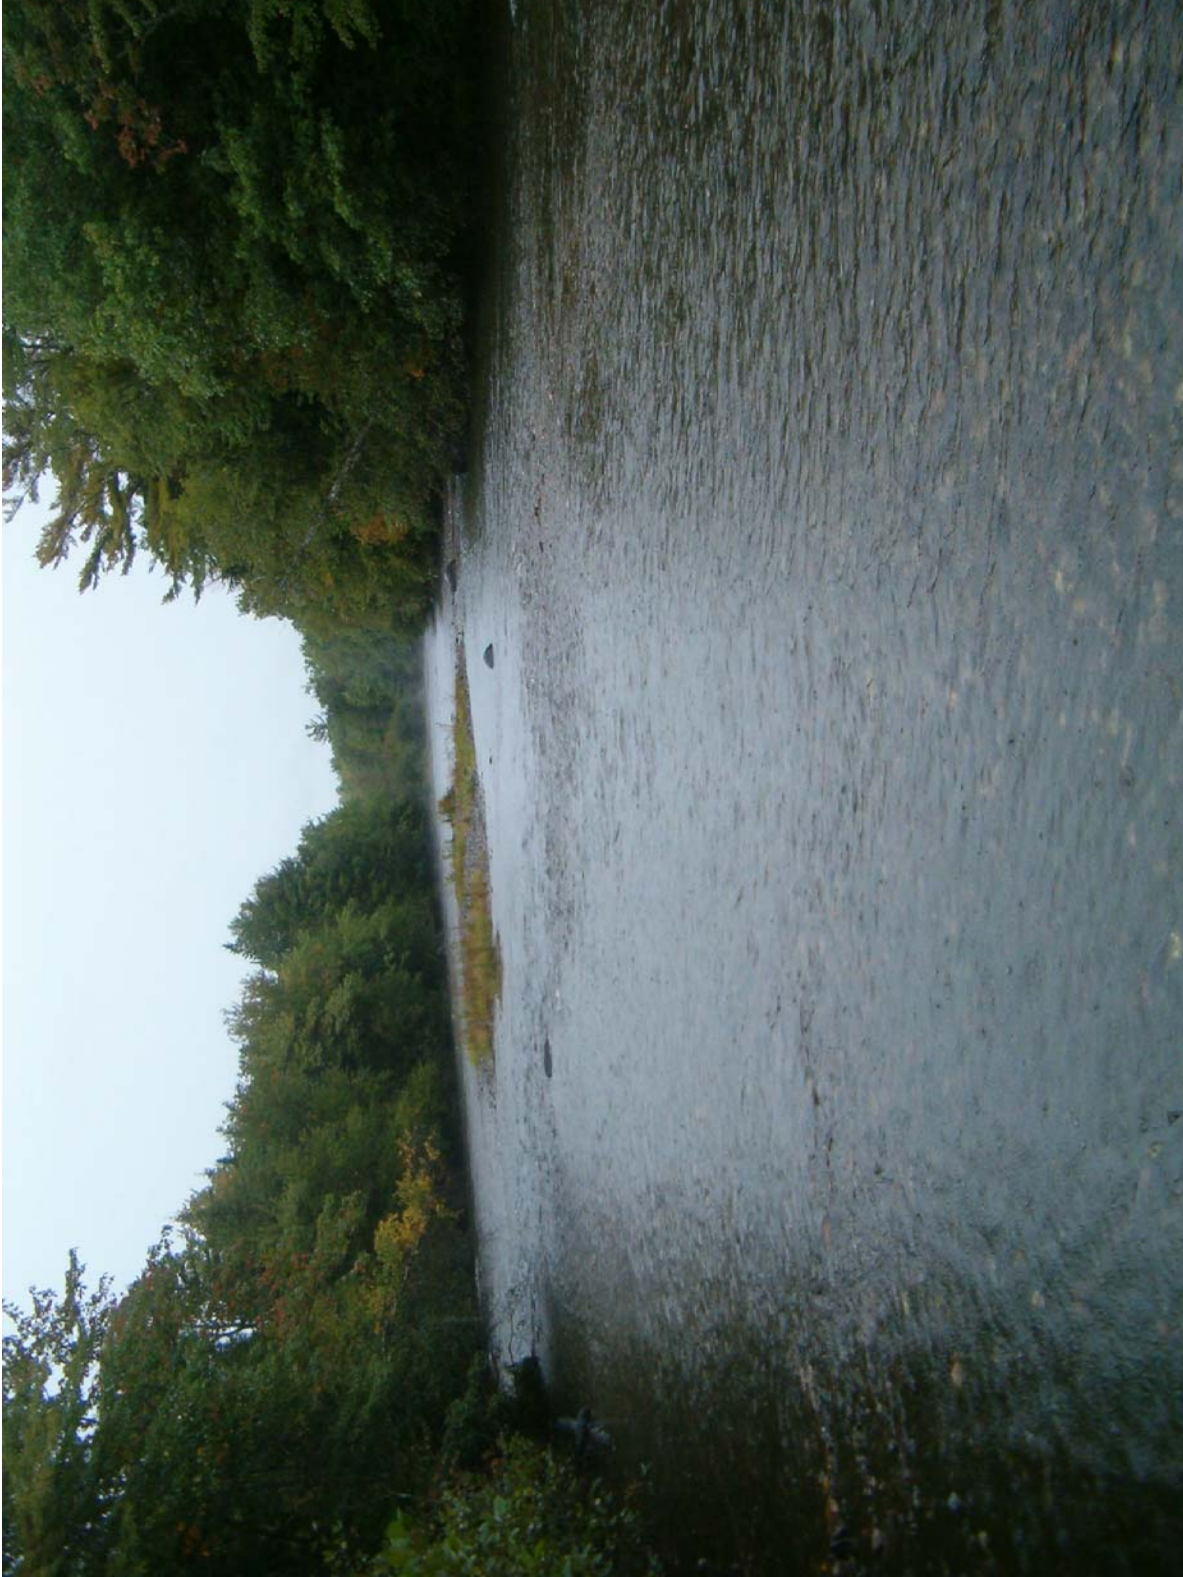
Study Reach 2

Reach 2 is located upstream of Little Falls and extends from multiple mid-channel bars downstream to a high eroding bank of glacial outwash sediments (Figures 2, 4, and 14). The reach was artificially straightened prior to 1917 (Figure 8) as evidenced by a wide low floodplain along the left bank with an abandoned meander; this old meander is likely the former position of the channel before straightening. Flow frequently overtops the left bank in many areas with fresh sand deposits and organic debris observed in the young floodplain forest. The lack of flow confinement in this reach contrasts with immediately upstream where the channel is confined by high nonalluvial banks on both sides of the channel. The upstream reach is further confined by artificial constrictors most likely constructed for log drives. Consequently, excess sediment is delivered downstream to Reach 2 where cobble and gravel deposition is occurring, because other

constrictors that previously blocked side channels have fallen into disrepair. Multiple mid-channel bars have been deposited as a result and a high width:depth ratio (>30.0) characterizes channel morphology. Pools are widely spaced and shallow, although, given the wide channel, pools are spaced every 2.9 bankfull widths (Table 2). In addition, the artificial straightening may have led to channel widening and loss of bed complexity (i.e., loss of pools) as the channel responded to the increased slope caused by straightening.

Note mid-channel bar forming in center of straightened channel

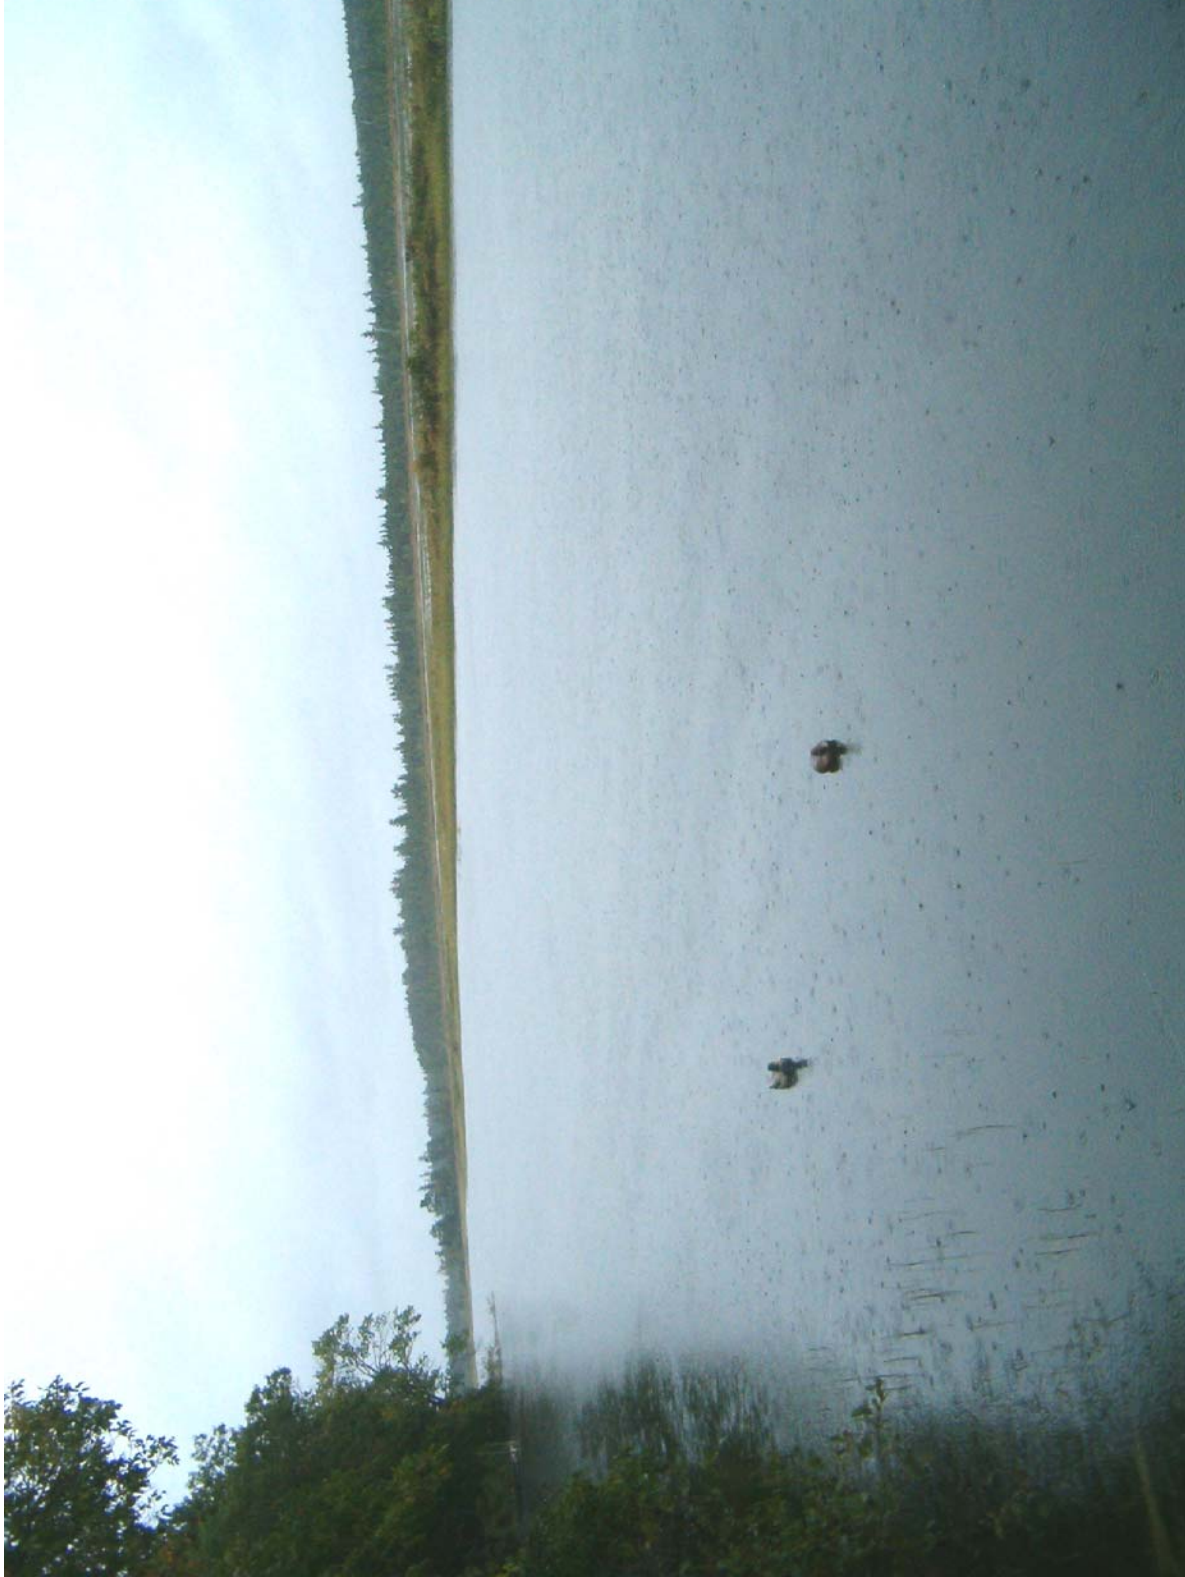
Study Reach 3

Reach 2 extends from Gould Landing, just downstream from the ledge controlled rapids, to the confluence with Big Lake (Figures 2 and 15). Given the length of the reach, surveying was subdivided into an upstream and downstream section (Appendix 3). A long narrow earthen constrictor defines the right bank of the channel for most of the reach (Figure 5 – Point D). The top of the constrictor is very low (Appendix 3), barely extending above the water surface, but does separate the channel from a marshy area on the opposite side of the constrictor. The constrictor is currently breached at the upstream end with minor amounts of flow moving into the marsh from the channel even at low flow conditions. The structure may have been higher in the past and was possibly constructed as log cribbing with rocks filling the center, as observed on another structure further upstream on the left bank (Figure 11). However, the internal structure of the long constrictor is currently obscured by mud deposits and shrub growth. The shorter constrictor on the left bank previously blocked flow from entering a side channel, but is now in such significant disrepair that flow crosses over the structure even at lower discharges (Figure 11).

Note: Looking downstream from dock at Kolemook Camp. Low bank on right of channel is artificial channel constrictor

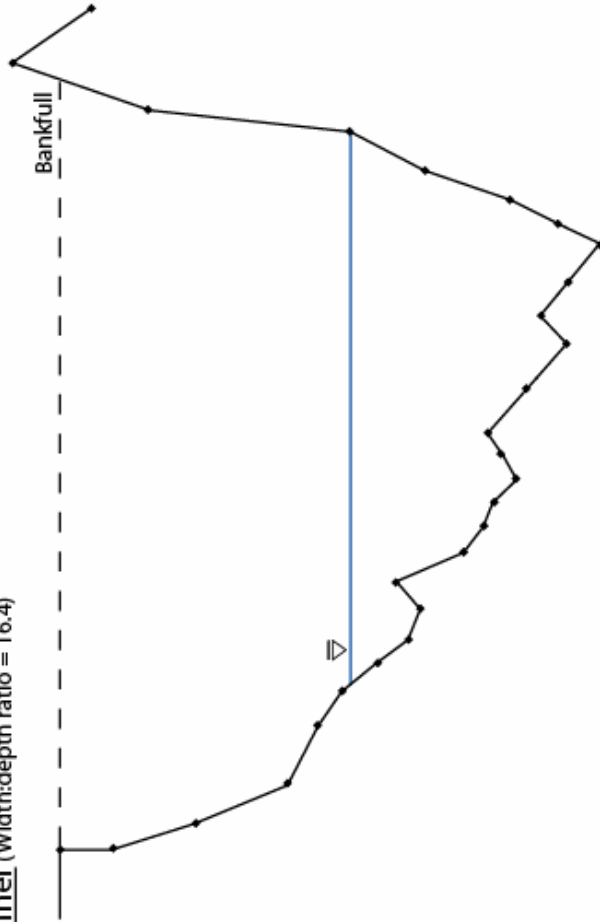
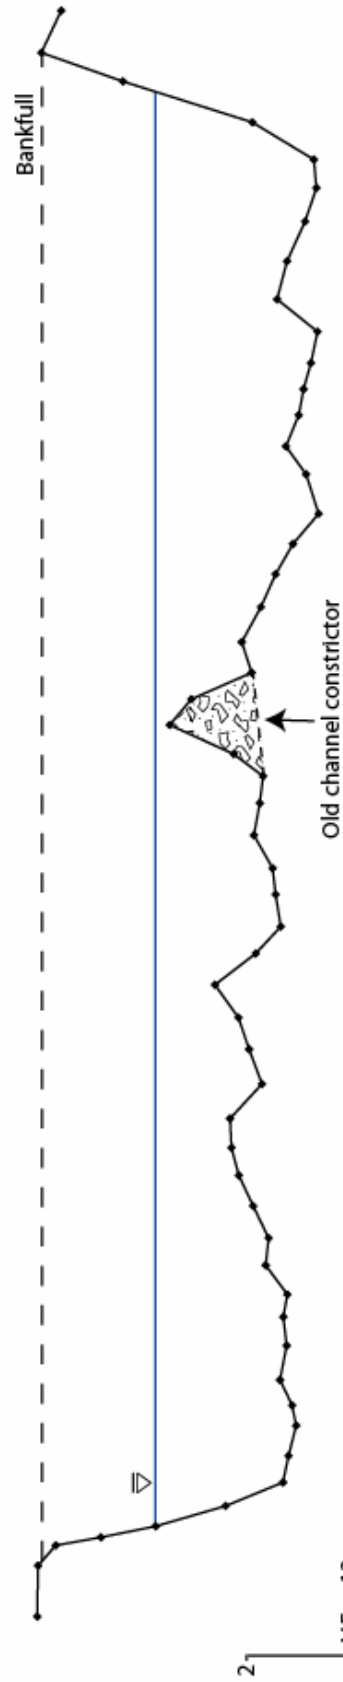
Cross Section Variations with Changes in Valley Confinement

As the channel leaves the rock ledges at Gould Landing the flow begins to spread out into a wide embayment of Big Lake. Although flow is still well defined and confined by the artificial constrictors described above, a delta of sand and gravel is building out into the channel as flow escapes into the side channel on the left bank and marsh on the right. The water surface slope is very low (<0.0001) as the channel enters the lake. Bed topography is also subdued with a very wide pool spacing (> 800 feet); the greatest "pool" depth is found at the base of the delta front (Table 2 and Appendix 3). The width:depth ratio of the channel is less than 20.0 immediately downstream of the rock rapids at Gould Landing but quickly becomes greater than 60.0 as flow spreads out into the side channel on the left bank; the currently dilapidated constrictor, when functioning, would have maintained a width:depth ratio of less than 30.0 by blocking access to the side channel (Figure 16). Despite the constrictor on the right bank further downstream,

the width:depth ratio is over 45.0, reflecting both the infilling of the channel with fine sediment and expansion of flow as the stream enters Big Lake.

Confined channel (width:depth ratio = 16.4)

Unconfined channel (width:depth ratio = 63.0 without constricter functioning and width:depth ratio = 27.9 when constricter functioned)
